CRWR Online Report 09-01

**Effectiveness of Natural Vegetated Areas for Stormwater Treatment:
Monitoring of the Falconhead West Development**

August 2009

**¹Center for Research in Water Resources
Bureau of Engineering Research
The University of Texas at Austin**

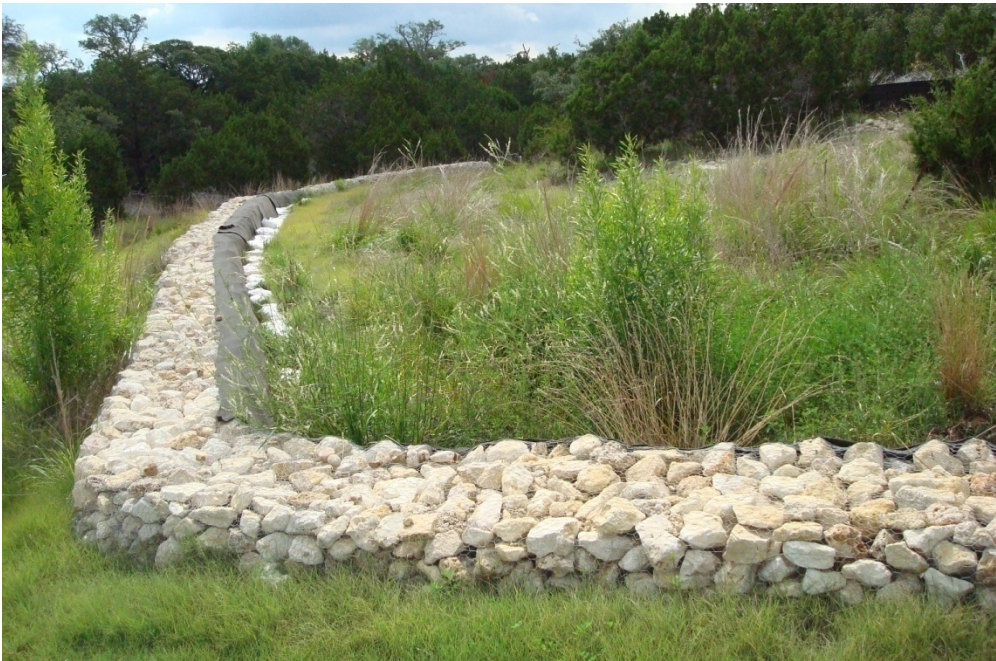
Figure 6: Ozark Path Level Spreader

Ozark Path and Swiss Alps storm drain outfalls are each dispersed across a 130 ft. level spreader during storm events. However, it should be noted that qualitative monitoring showed that only a portion of the level spreader length was effective at distributing runoff into sheetflow. These level spreaders are a rock berm design and comprised of 3"-5" open graded rock encased in woven wire sheathing and can be seen in Figures 6 and 7. The level spreader is designed to convert a concentrated inflow into a uniform exit sheetflow to distribute across the VFS. LCRA 2007 defines sheetflow as a flow depth less than 0.2 feet with a velocity less than one foot per second during the 1-year, 3-hour storm.

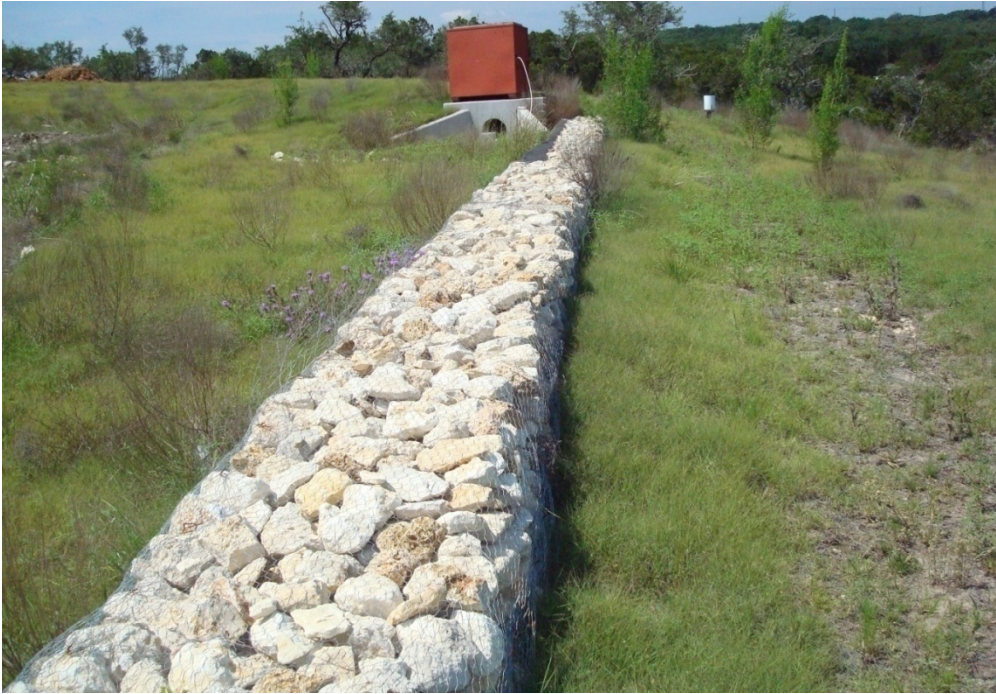
Figure 7: Swiss Alps Level Spreader

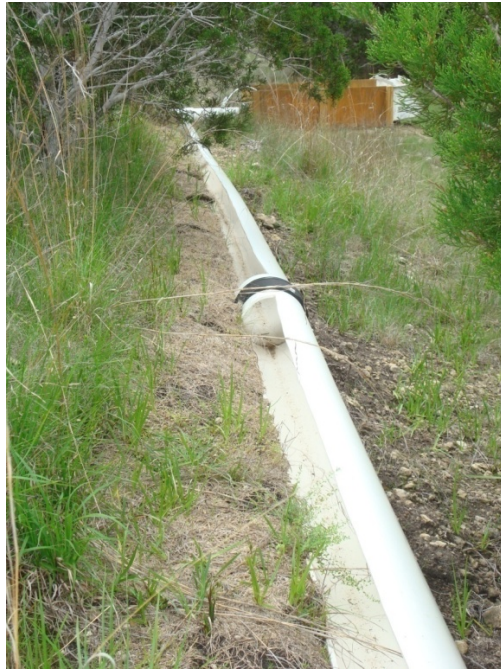
Figure 8: Ozark Path Downslope Collector

The rock berm level spreaders generate sheetflow upslope of a natural VFS approximately 70 ft. in flow length. The last portion of the natural VFS is a Glen Rose Formation riser with slopes greater than 30%. Following the initial abstraction and infiltration along the natural VFS remaining runoff is collected at the toe of the risers with 8 in. PVC collection pipes shown in Figures 8 and 9. The collection pipes are installed flush with the ground level across the natural VFS with a longitudinal slope of approximately 0.5% to direct water to the monitoring collection box. Sod was placed and manicured directly upslope of the collection pipes to stabilize soil and attempt a water tight connection between the ground and collection pipes. Runoff flows into a collection box with a 1.5 ft. H-flume outfall at Ozark Path and 1.0 ft H-flume at Swiss Alps. These H-flume outfalls are equipped with both the ISCO 4230 bubbler flow meter and ISCO 3700 automatic sampler. Total flow volume was again calculated by integrating the flow rate hydrograph over the entire storm event and automatic samplers programmed to collect flow weighted composite samples. All flow meters, samplers and rain gauges are powered by a solar panel and marine deep cycle 12 volt battery.

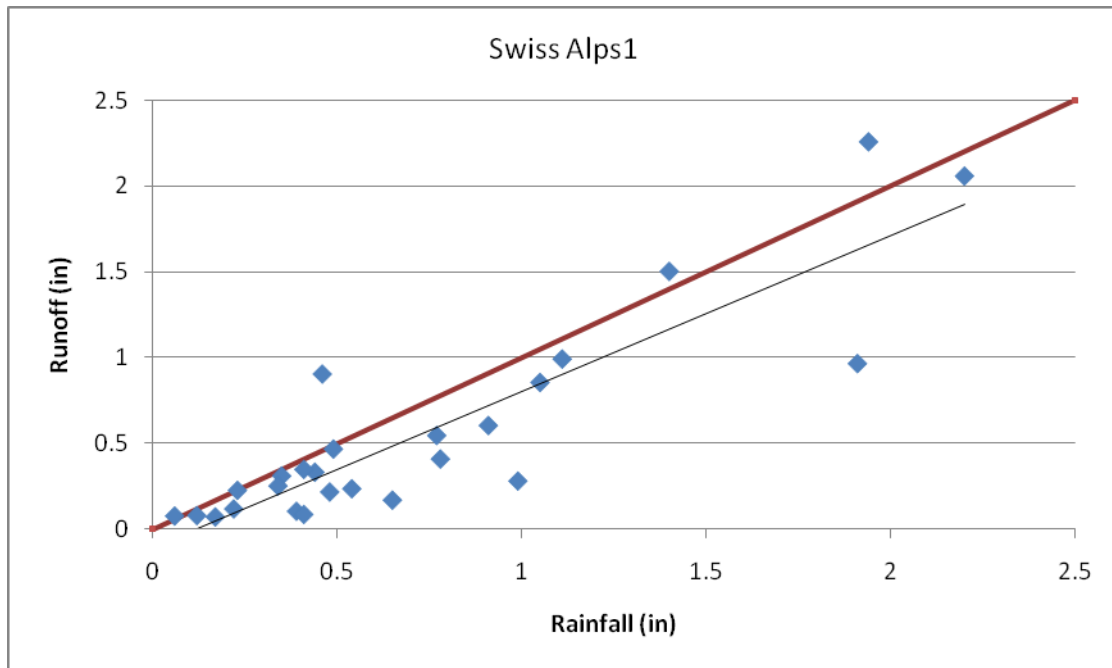
Figure 12: Swiss Alps Upstream Rainfall-Runoff; $\text{Runoff} = 0.91 \times \text{Rainfall} - 0.01$

Each monitoring location rainfall and runoff results for individual events are presented in Figures 10-13. Distinctions between upstream and downstream runoff ratios can be seen in the slope of the regression line. Larger runoff ratios occur upstream of the VFS with the 1:1 rainfall to runoff ratio presented for comparison. Initial abstraction is also evident at both downstream locations. Approximately 0.4 in. of initial abstraction occurs in both VFS before the downstream collectors observe any flow. This initial abstraction makes capturing paired upstream and downstream samples only possible for moderate to large storm events.

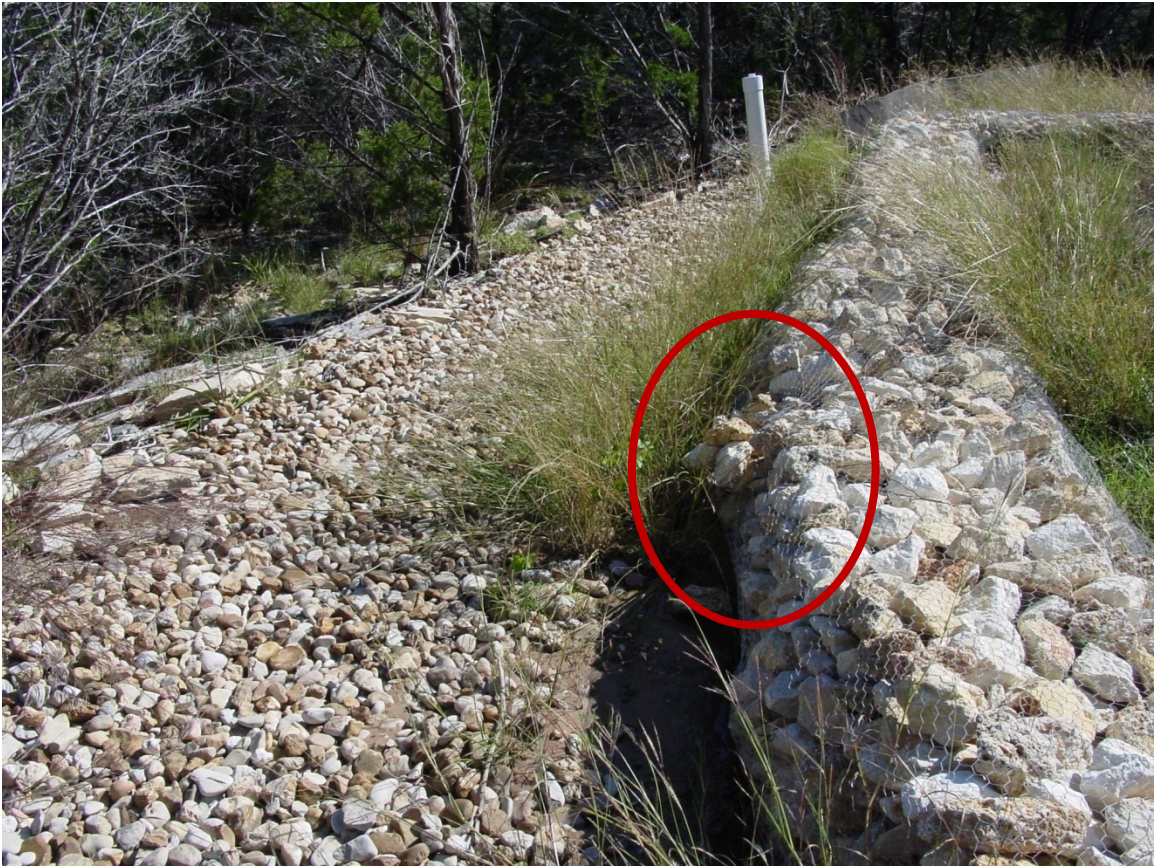
Figure 14: Break in Rock Berm Wiring of System M

Every three months a qualitative review was conducted of the 18 LS-VFS systems in the Falconhead West Development. This review was helpful in identifying trends of BMP performance and required maintenance. Over the monitoring and inspection period multiple flow level spreaders became increasingly filled with sediment and debris. Three level spreaders incurred breaks in the woven wire sheathing containing the rock berm. Figure 14 shows a break in the rock berm wire cage of system M. Breaks in the wire basket can indicate that concentrated inflow to the level spreader is not dissipating into shallow sheetflow but was staying concentrated in the break location. A map of all LS-VFS systems and time series photo documentation are presented in Appendix E and F respectively.

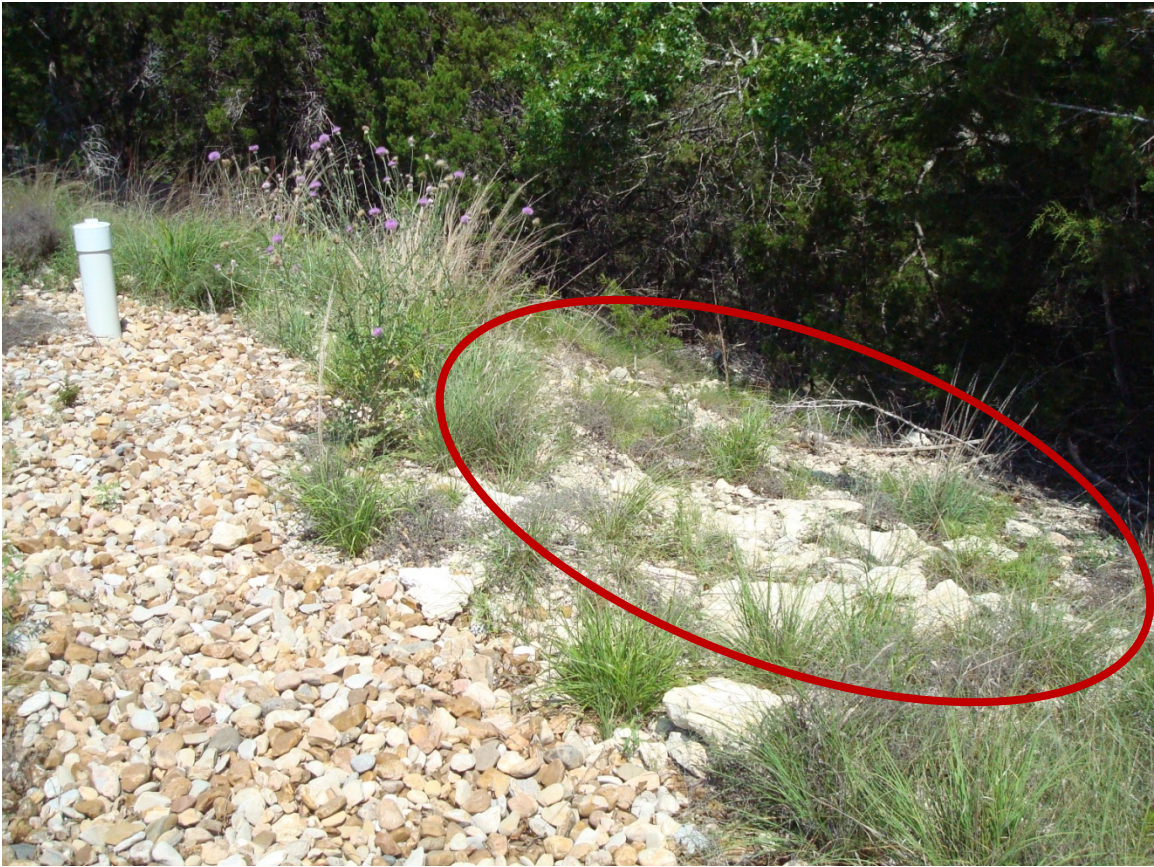
Figure 15: Downslope Erosion on System T

Even in cases when woven wire cages were not broken significant downstream erosion was apparent at multiple sites. Figure 15 presents erosion downslope of the level spreader of system T. The erosion can be an indication of level spreaders not functioning appropriately, due to faulty construction or placement on a non-uniform grade. A level spreader field evaluation by Hathaway and Hunt (2009) found similar results with lack of maintenance and buffer topography as the leading causes of level spreader system malfunctions. Even when spreaders are functioning properly variable topography along the natural VFS can cause flow to re-concentrate causing increased erosion and short circuiting of the VFS, reducing the potential VFS treatment performance.

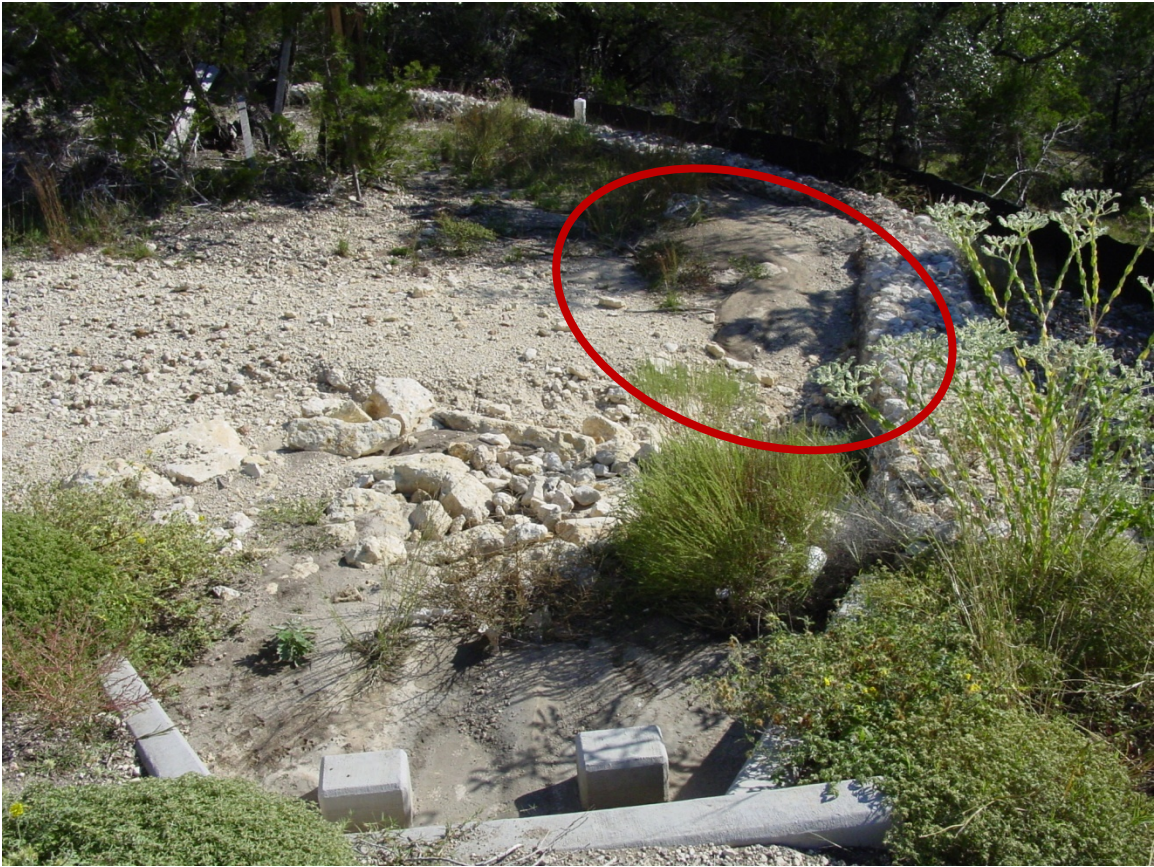
Figure 16: Sediment Accumulation in System V

Sediment deposition behind the level spreaders indicates that this area provides pretreatment prior to the natural VFS. However, as the level spreaders approach sediment capacity runoff will eventually circumnavigate the flow spreader and enter the VFS in concentrated flow. Figure 16 illustrates sediment accumulation in LS-VFS system V.

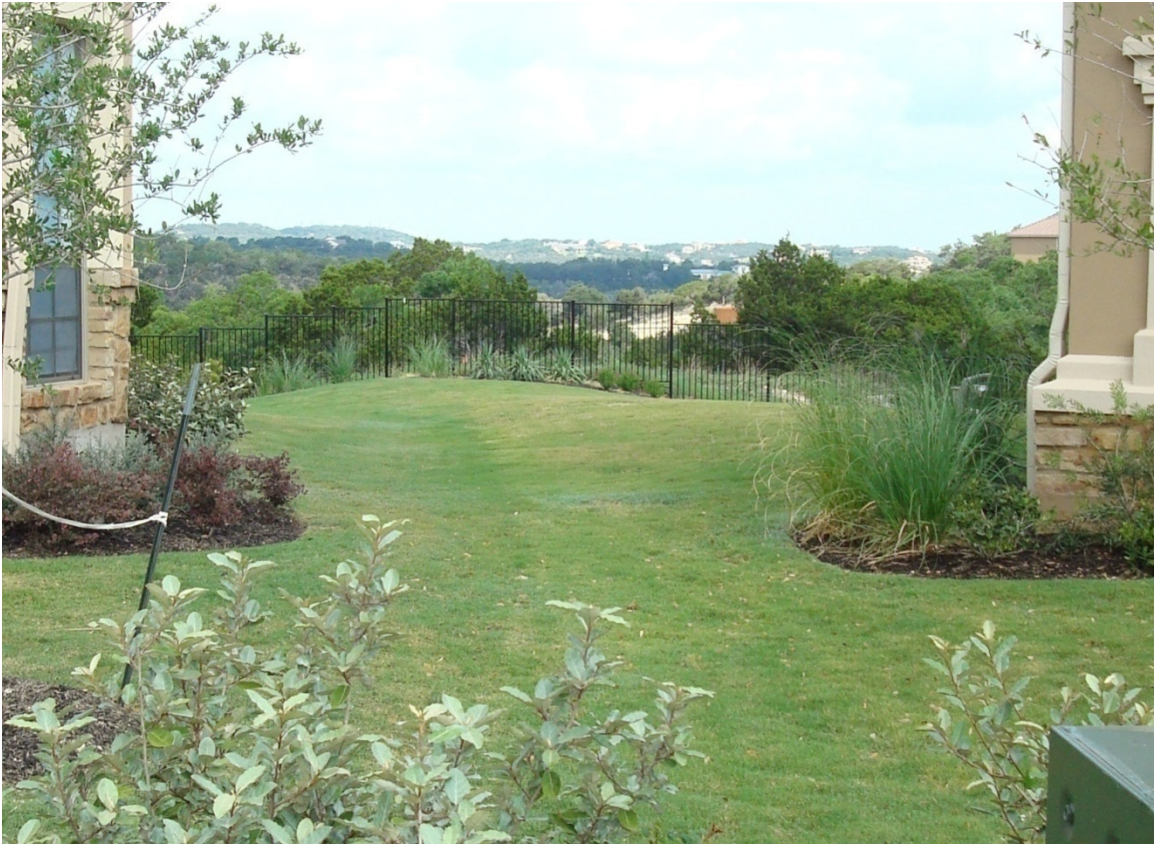
Figure 17: Lack of Maintenance Access to LS-VFS Systems

These observations are evidence of the need for maintenance access of LS-VFS systems. Most LS-VFS systems in the reviewed residential development are isolated behind continuous residential fences of developed lots, shown in Figure 17. Maintenance access to the level spreaders should be considered during design to provide opportunities for sediment removal, berm repair, and other activities.

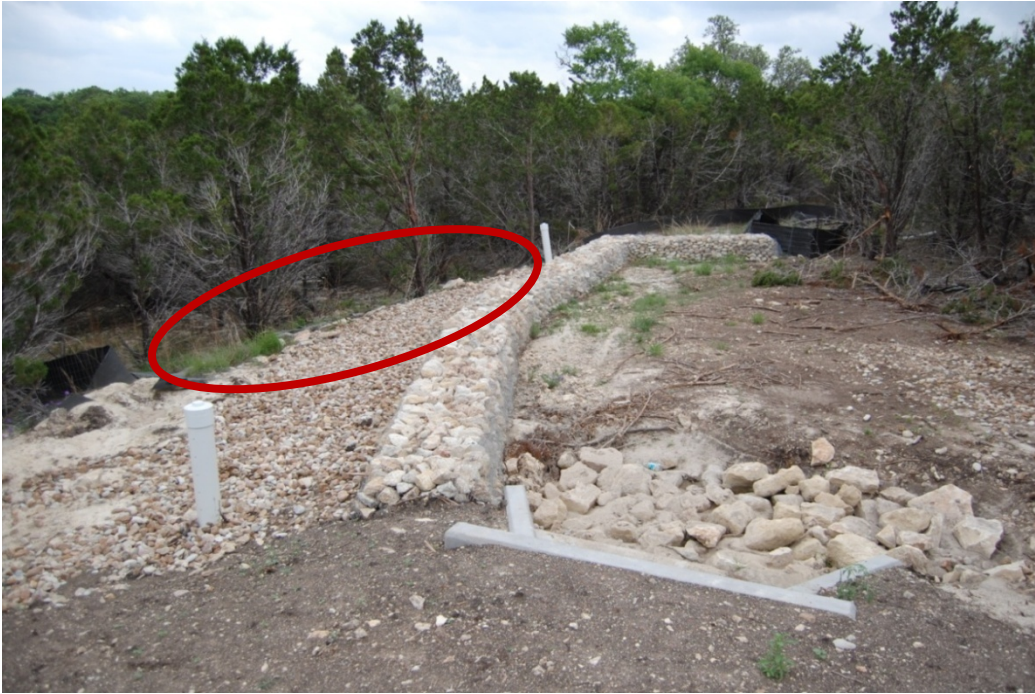
May 2008, Downslope Erosion

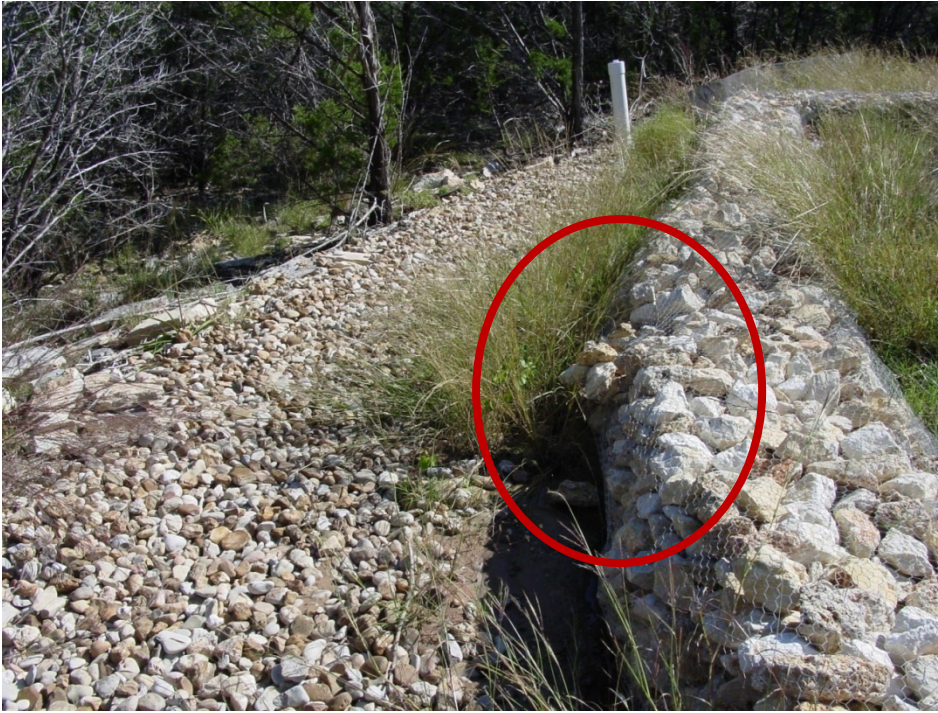
October 2008, Broken Wire Cage

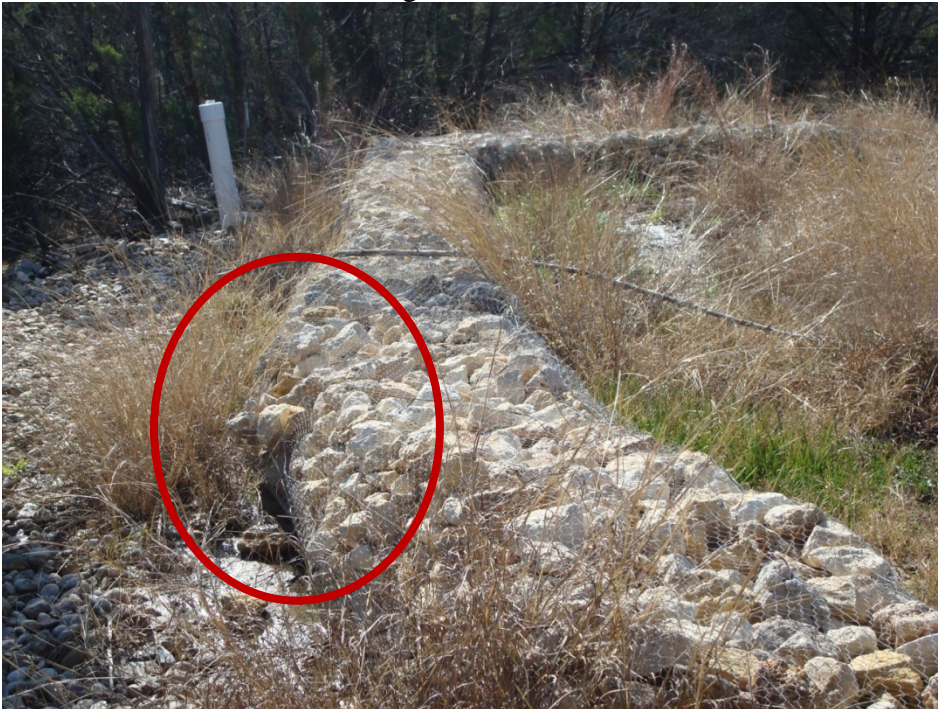
January 2009, Broken Wire Cage

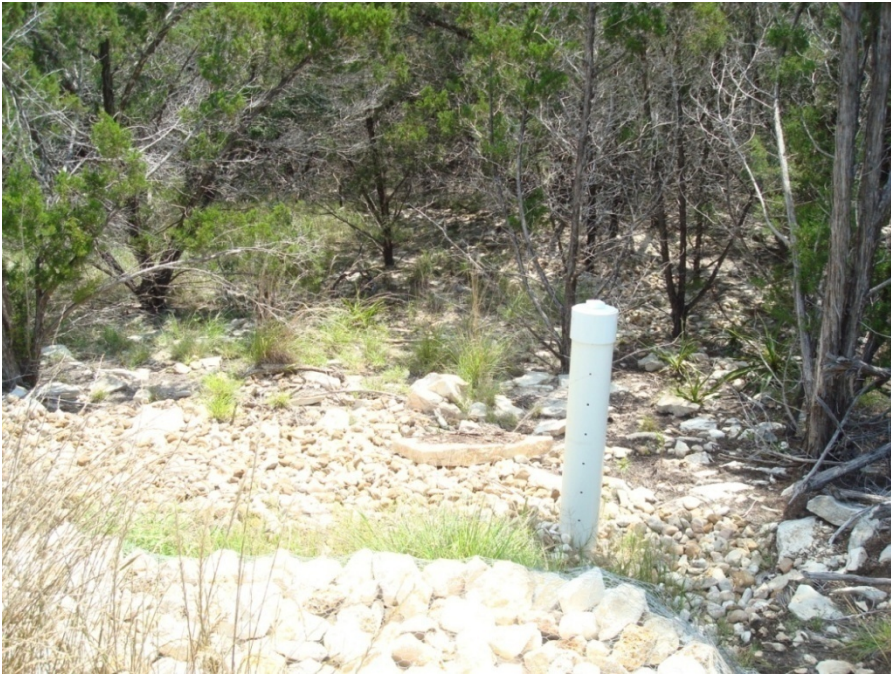
June 2009, Downslope Erosion

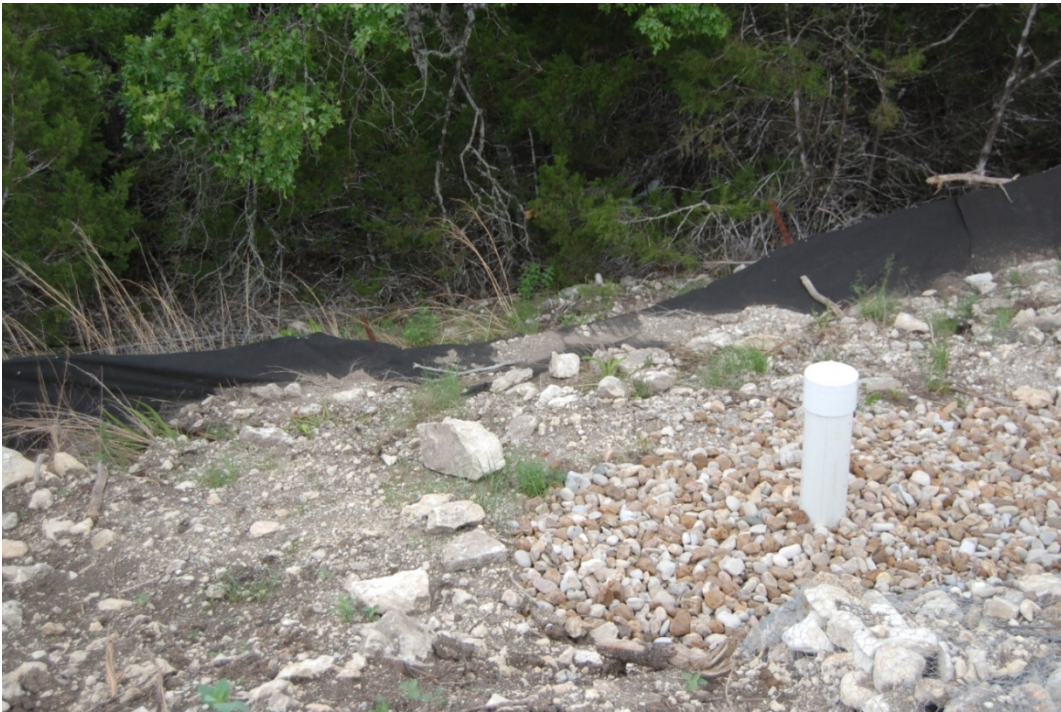
May 2008, Downslope concentrated flow and erosion

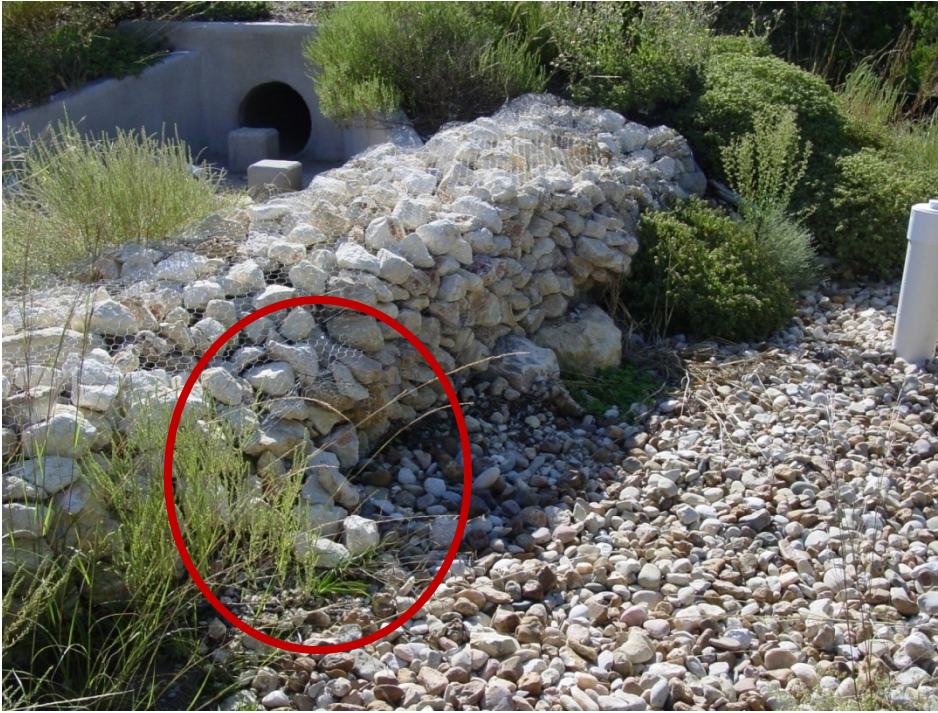
October 2008, Broken wire cage
